U.S. 101 MP 98.47 Unnamed Tributary to West Fork Hoquiam River (WDFW ID 993702): Preliminary Hydraulic Design Report

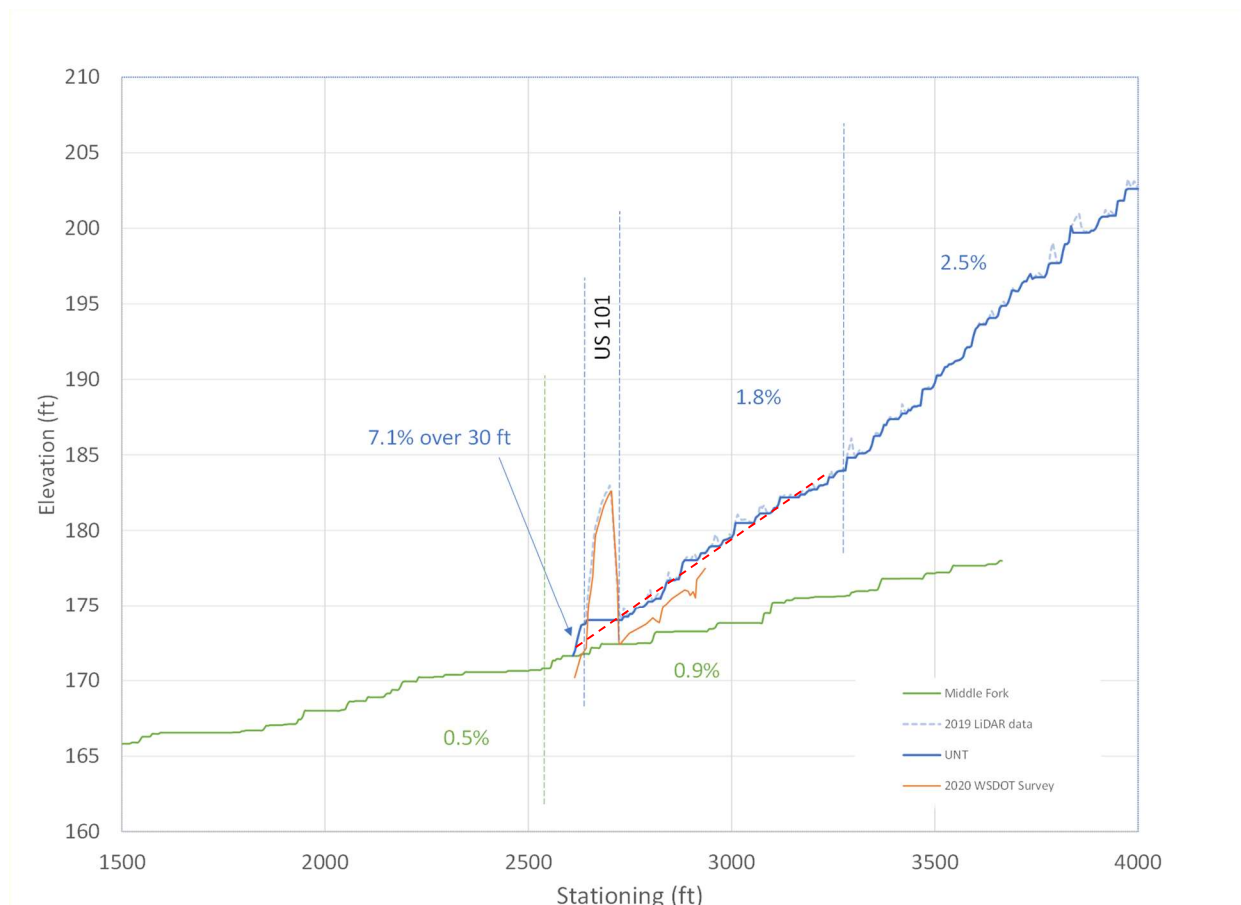
Figure 14: Watershed-scale longitudinal profile and gradients of the Middle Fork Hoquiam River and project stream; plot includes comparison of LiDAR with WSDOT survey data; dashed red line is upstream grade extended downstream

likely than degradation, where the constructed channel may regrade to be in line with the upstream grade. The maximum amount of degradation based on extending the upstream profile downstream is approximately 2 feet at the outlet, and less than -0.5 feet at the inlet (cf Figure 14).

The West Fork Hoquiam River profile does not indicate any significant discontinuities, and the confluence is upstream of another reduction in grade (Figure 14). In section 2.8.5, no historical lateral migration was observed, and the potential for avulsion was deemed unlikely. However, the wood steps downstream of the confluence could deteriorate and possibly wash out, lowering the grade control up to 1.0 foot or a low of 170.6 feet. Because the West Fork Hoquiam River sets the fundamental base level grade control for the creek, lowering of the mainstem grade would propagate upstream, 100 feet on the mainstem and 30 feet up the tributary. The average gradient of the West Fork is 0.9%. The minimum slope observed upstream of the crossing (1.8%) provides a conservative estimate of the expected regrade slope and so this scenario sets the minimum plausible channel grade at the downstream side of the crossing by extending the profile as discussed above, down to approximately elevation 172.1 ft. Because this elevation is based on several conservative additive assumptions, it is relatively unlikely that the stream bed will lower to this elevation over the design life of the culvert. This amount of degradation is especially unlikely given hydraulic modeling of flood flow for both systems; this shows a significant backwater control from the West Fork (source), that may reduce the propensity for flows in the project stream to cause incision during coincident high flow events.

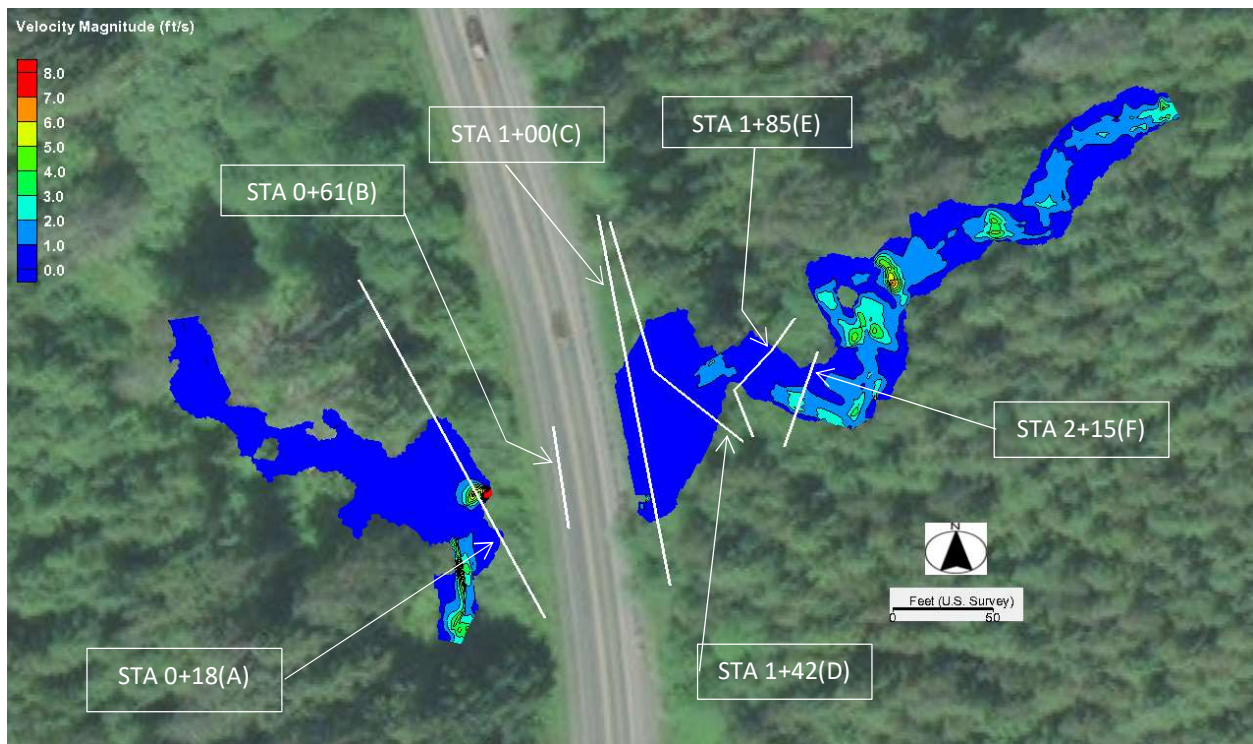
Figure 37: Existing-conditions present day 100-year velocity map (tributary only scenario)
